THE RCEME AND TIGER #007

by Ignace Vangel

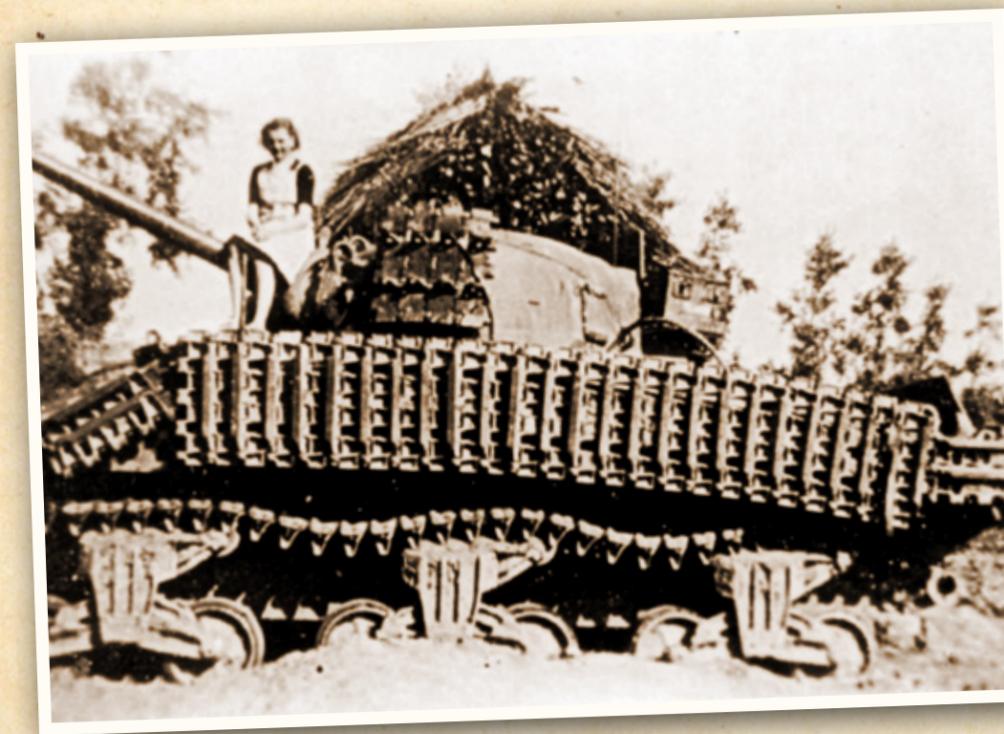
Sherman V tanks from the South Alberta Tank Regiment were both knocked out at Moerbrugge in Belgium in September 1944. The tracks welded to the hulls and turrets were taken from Panther tanks.

The South Albertan tank regiment had been one of the first Canadian tank units in Normandy to make extensive use of the tank tracks as supplemental armour on their Sherman tanks. While at Caen in July, just prior to the advance toward Falaise, the Sherman tanks from all companies of the Regiment were sent back in rotation from the front lines to the LAD/AWD workshops, where teams of welders worked non-stop, night and day to weld German tank tracks onto the hulls and turrets.¹¹ Though the 42 LAD diary entries describe "Tiger tracks" welded to the South Albertan Shermans, the photographs depict the use of the more commonly available Panther tank tracks. However, the much wider (and rarer) Tiger tracks, when available, were also used, apparently being welded mainly on the glacis plate on Sherman tanks of the South Albertan and other Canadian tank regiments.

The use of tank tracks welded to the front and sides of the hull and sides of the turret as supplemental armour was controversial due to the extra weight and subsequent wear to the tank engines and transmissions. Nevertheless, the use of tank tracks on Sherman tanks was widely practiced by the Canadian tank regiments in northwest Europe throughout the war. The diary of the 5th Canadian

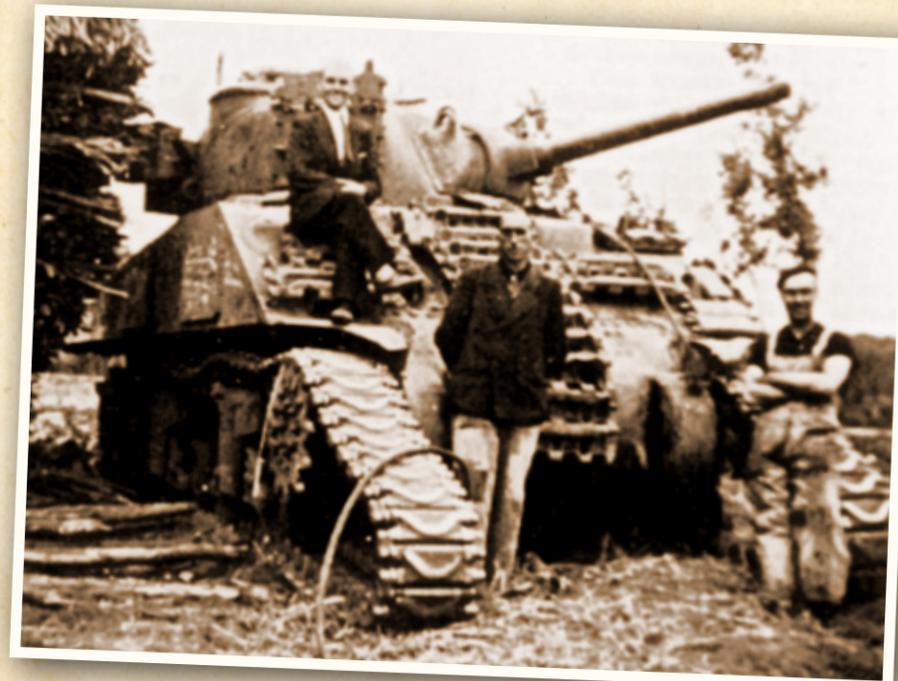
Another Sherman V tank from the South Alberta Tank Regiment with Panther tracks welded to the hull for extra protection.

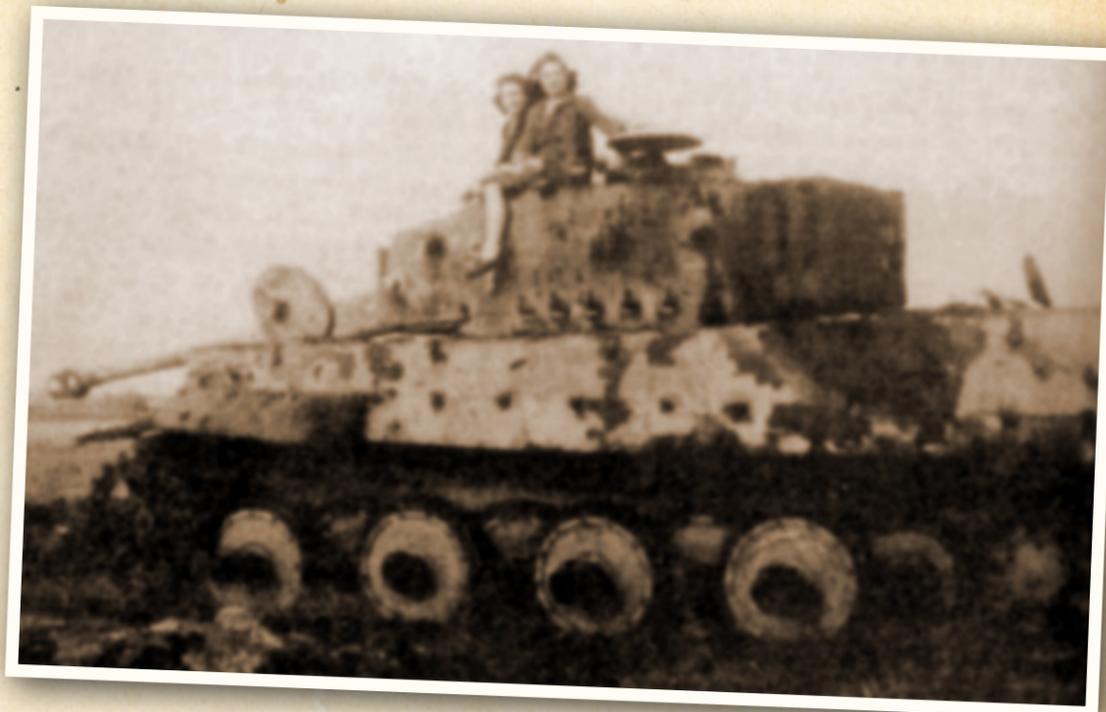
After the battle in which Tiger No.314 was lost, this photos documents the removal of the outer rubber tyre road wheels. This practice was likely carried out by the local residents. The wheels were either sold for scrap or retained for farm use.

3) Tiger battle tank, tactical number 314: One of four reconverted command tanks shipped to the battalion in November 1943. This tank was originally completed as a command tank in August 1943 but was reconverted back into a battle tank in late October 1943. Originally assigned to a crew in the 3rd. Co., it was taken over by the former battalion signals officer, SS-Untersturmführer 'Willi' Ihrion of the Headquarters Company before the battle. The tank was retreating southwards when hit in the left side of the turret by a 17-pdr AP shot. It then burnt out. There were no survivors.
